Limited Visual Dam Safety Inspection Summary Report

MA-144

Maui County Water

Limited Visual Dam Safety Inspection Conducted on: 07 April 2006

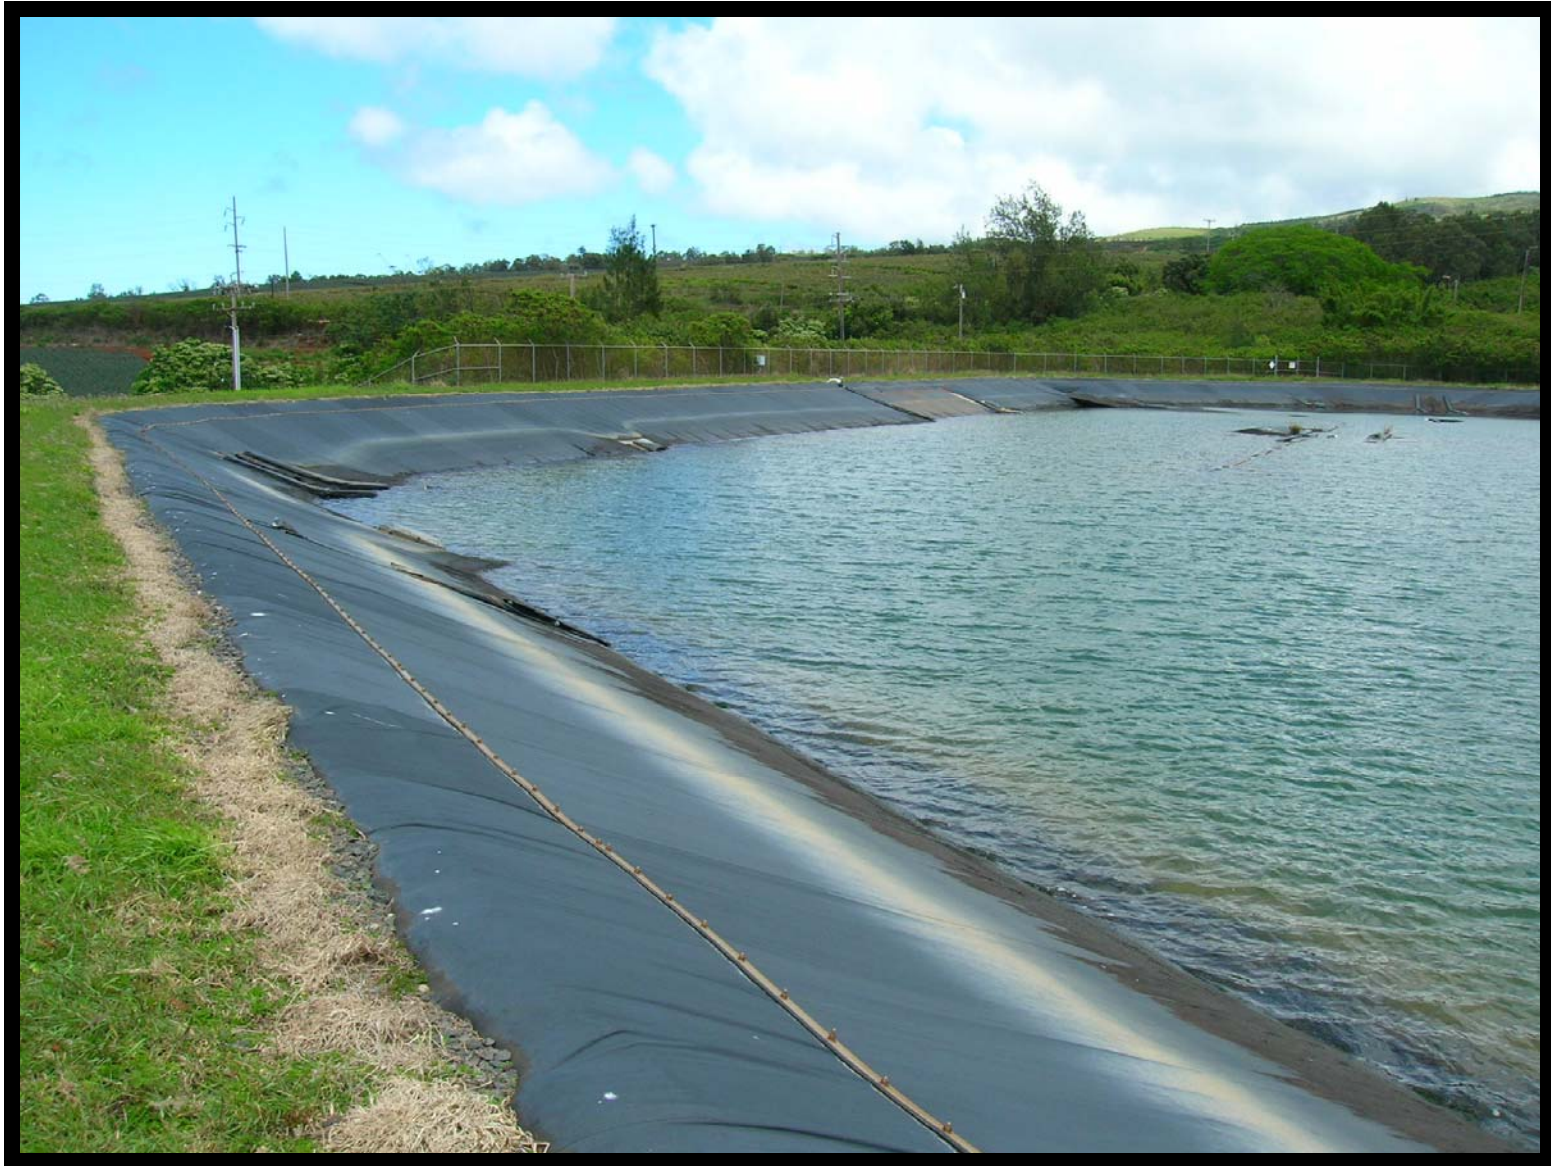
144 view of upstream slope of the dam 1

The upstream slope was covered by the liner (HDPE); therefore, cracks and sinkholes were not visible at the time of inspection.

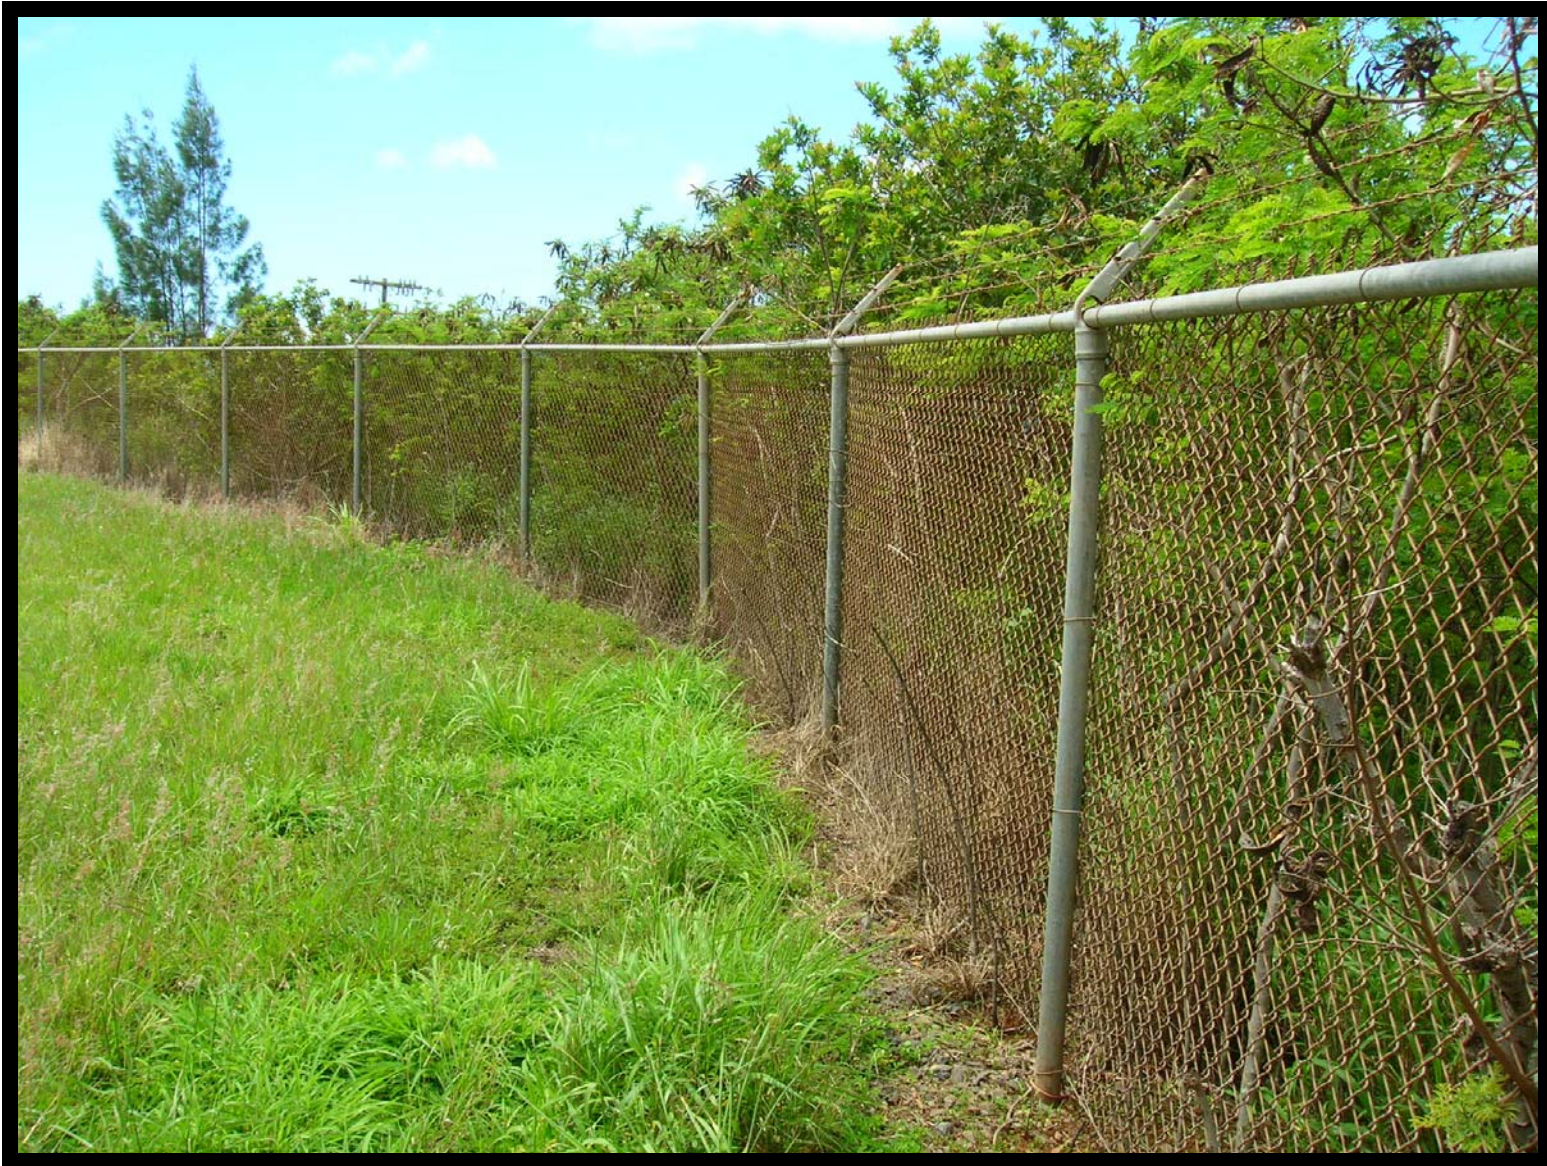
144 View of the dense brush and small trees located on the section of dam maintained by Maui Land and Pineapple, LLC (opposite side of fence).

- a. The abutments/toe appeared to be in fair to poor condition and requires corrective action.
- b. The abutment/toe area was not visible due to high grass and bush vegetation. Clear high vegetation and maintain low to enable easy visual inspection.
- c. Corrective action only for the toe and right abutment on Maui Land and Pineapple Co. maintained property.
